Defence Air Safety Occurrence Report including Comments and Actions

asor\Marham - RAF\31 Sqn\Tornado\18\7655

Airprox with F16 FL150 - UKAB 2018183

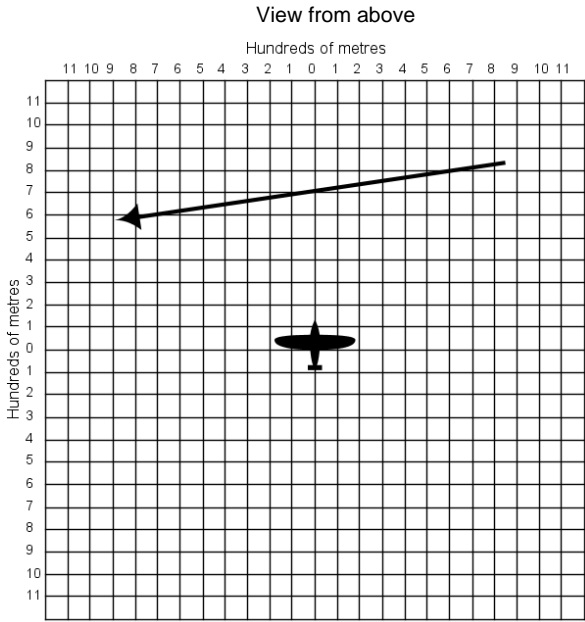
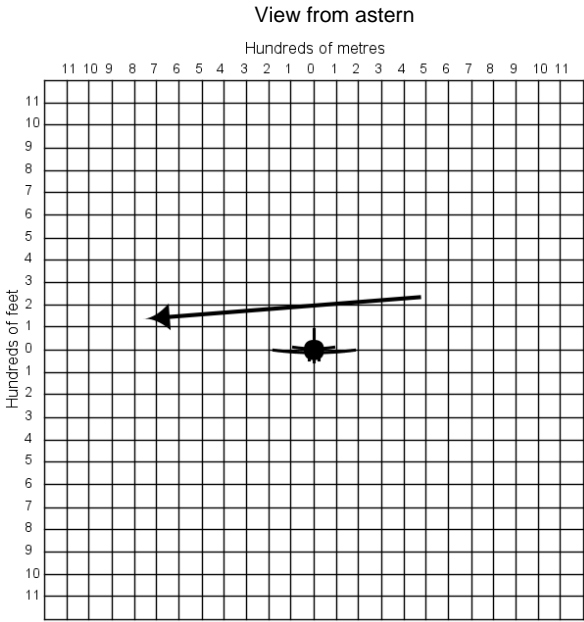
Monster Flight had departed RAF Marham and been handed over to Coningsby App due to Swanwick Military being unable to accept control. At FL150 with MR 2 approx. 2 nm in trail, West abeam Holbeach Range, MR1 observed a TIEC Track outside of Holbeach Range displaying an altitude of approx. 15000'. MR2 TIEC did not display the TIEC track at any time. MR Flight were under a Traffic Service from Coninsby App. Within 30 seconds MR1 became visual with the F16 who passed right to left across MR1 nose and within 500 feet of Monster Formation, 6nm to the NW of Holbeach overhead Boston. MR2 descended 1500 feet to remain visual with the F16 and VMC, and MR 1 came right to avoid, with the F16 passing down the left hand side of both aircraft, then continuing to the South.

MR1 immediately contacted Coningsby App who were initially unaware of the F16 but then identified that the aircraft had been working inside Holbeach Range but had spilled out to the NW. The F16 was not squawking throughout and as such no TCAS information was generated.
